HERITAGE NEW ZEALAND  
POUHERE TAONGA

## Sustainable Management of Historic Heritage Guidance Series

# Repairing and Rebuilding Historic Chimneys after an Earthquake

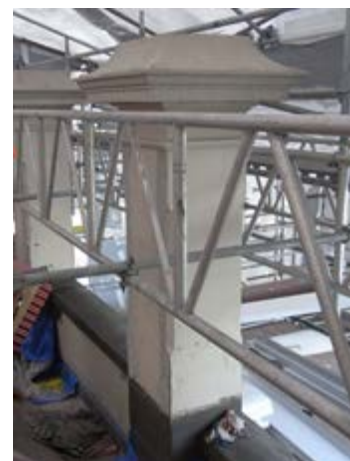
**Rob Roy Hotel, Auckland.**

Reinforcing of chimneys with carbon fibre strips. This is an option when a chimney has a covering plaster/paint finish. Photo, Heritage New Zealand
